Quality Environmental Solutions & Technologies, Inc.

Re: Project No. Q18-1941 Pequenakonck Elementary School, Post-Remediation Assessment and Clearance Summary

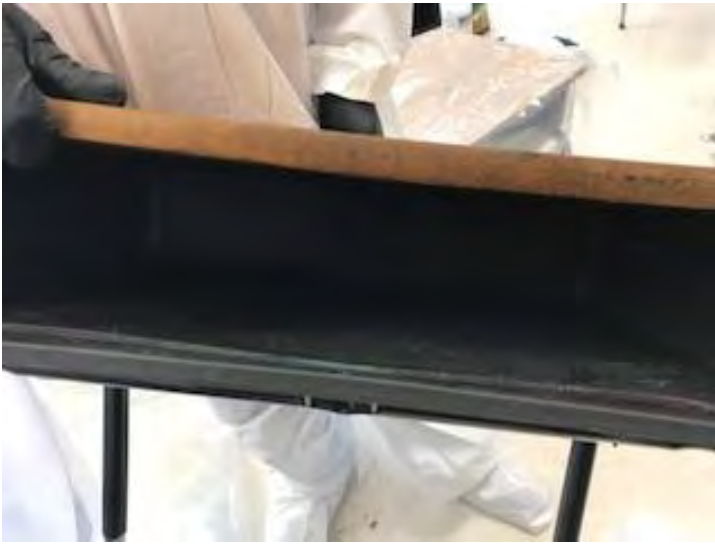
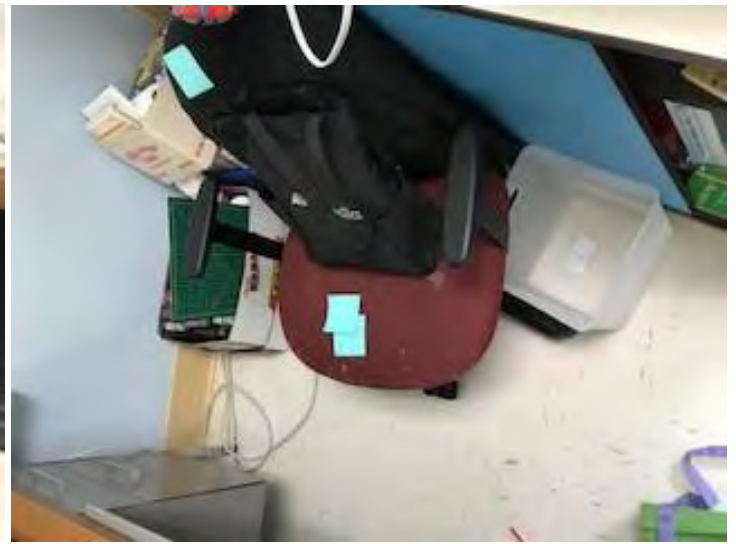
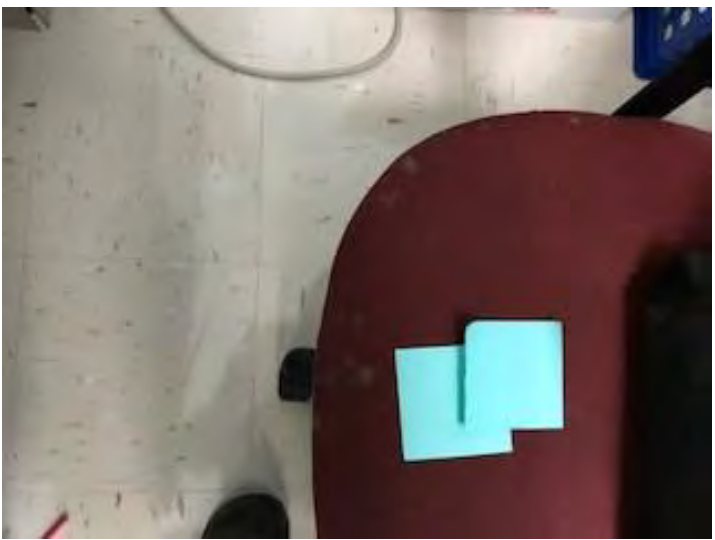
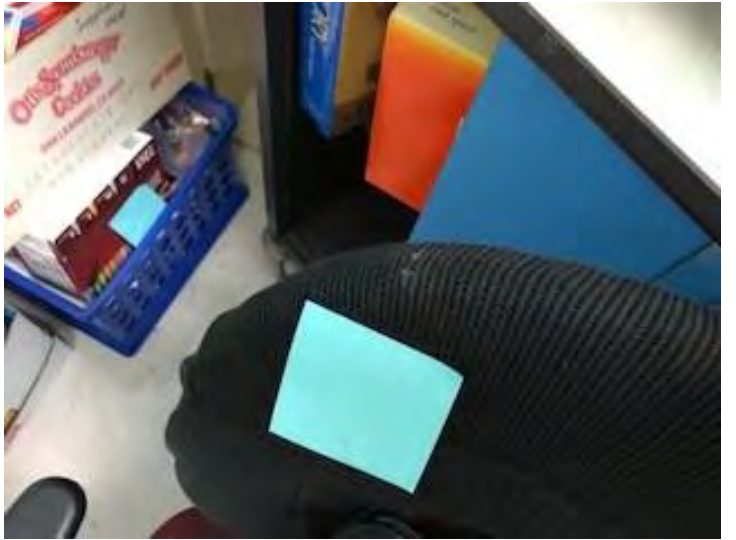
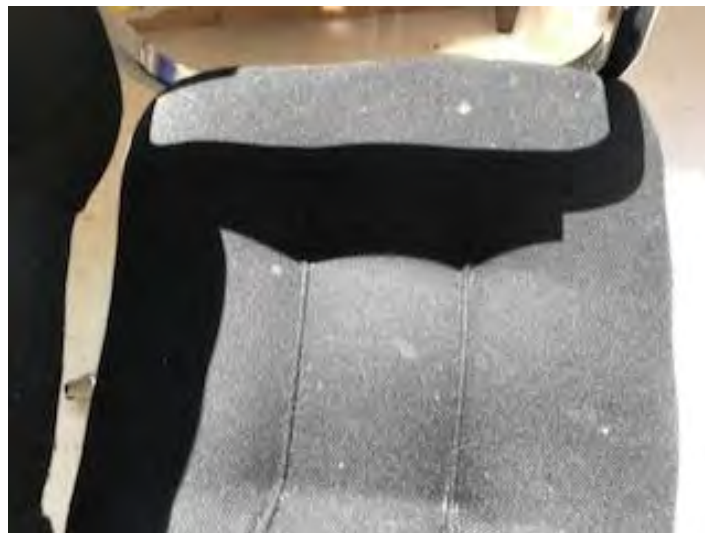
Figures 1.1-1.5 Above Show Spots of Microbial Growth On Desks and Chairs

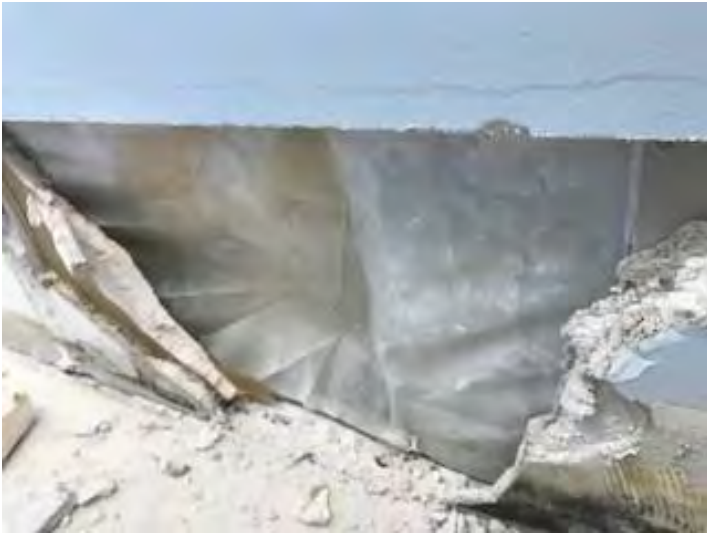
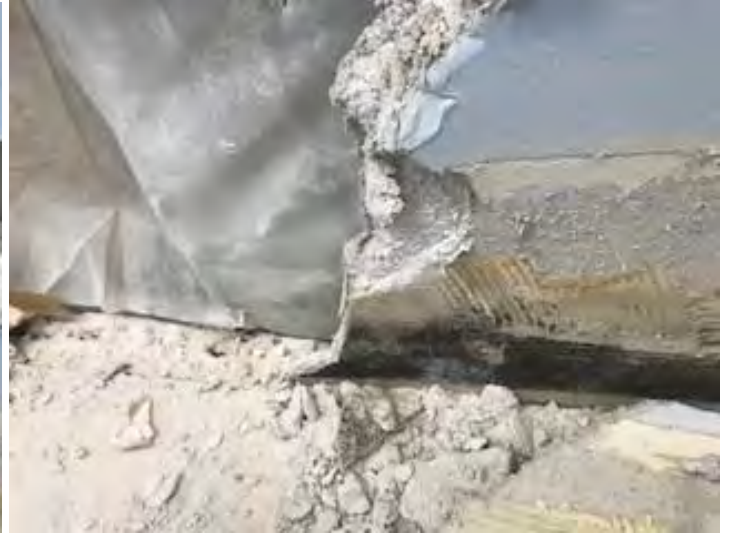
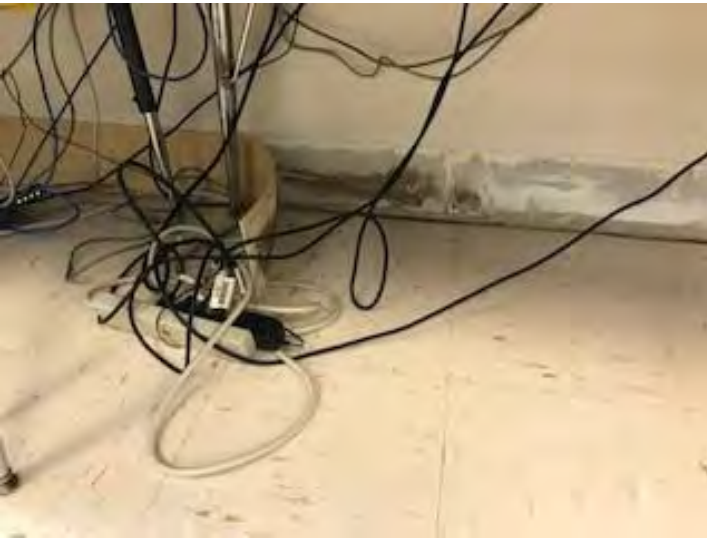
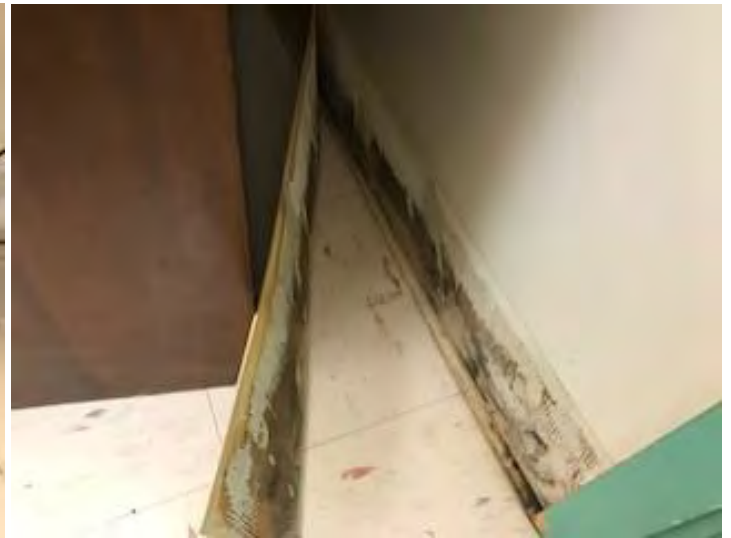
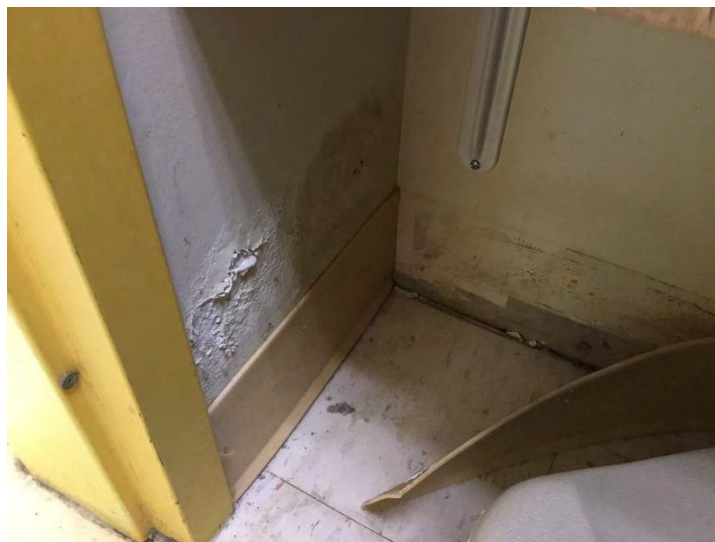
1. On August 24th, mold growth was observed on and behind cove base moldings along sheetrock walls. Therefore, the licensed Mold Contractor removed 6in. of sheetrock from the ground up in various rooms. A map showing the various rooms where sheetrock was removed, is listed in Appendix C (See Photos).

Figures 1.6-1.10 Above Show Microbial Growth Hidden Behind Cove Base Molding & On Adjacent Sheetrock

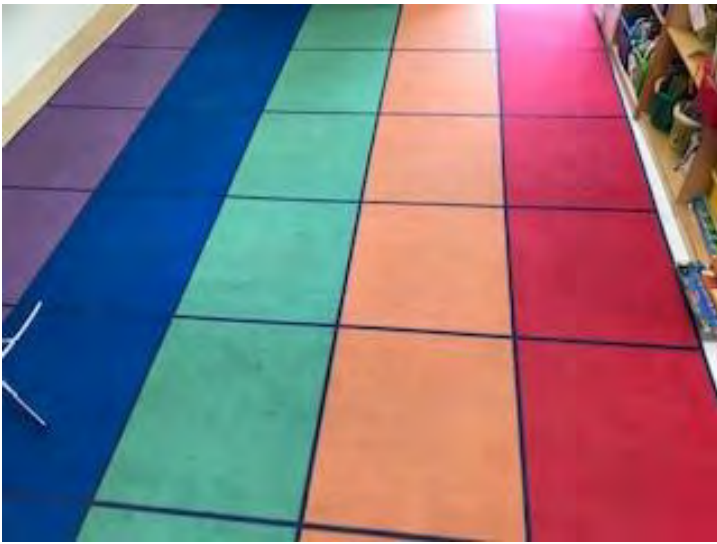
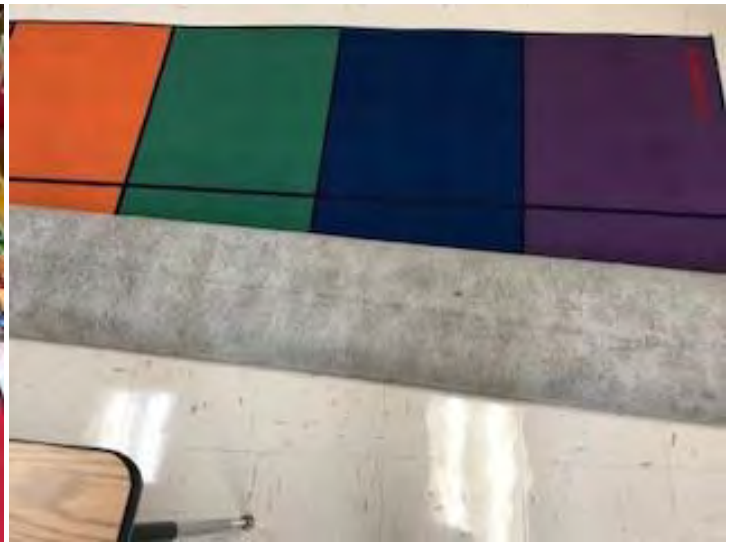
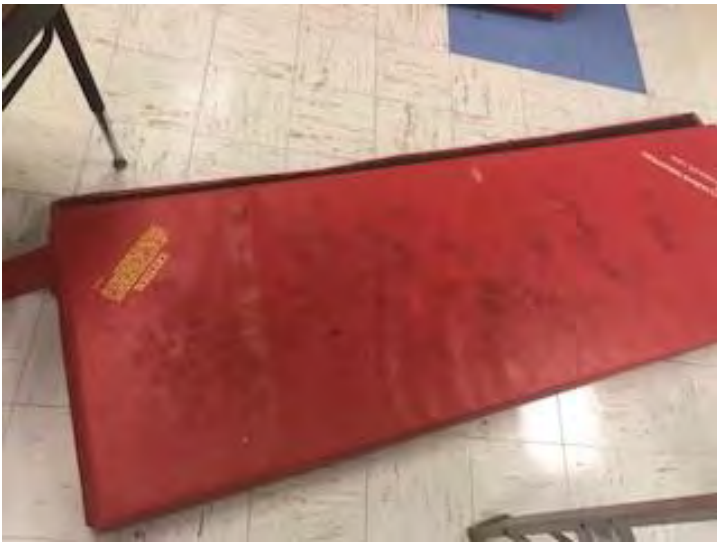
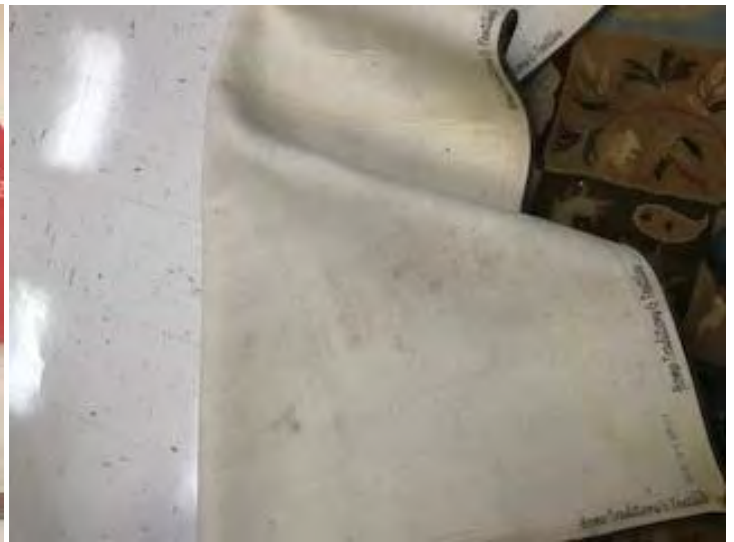
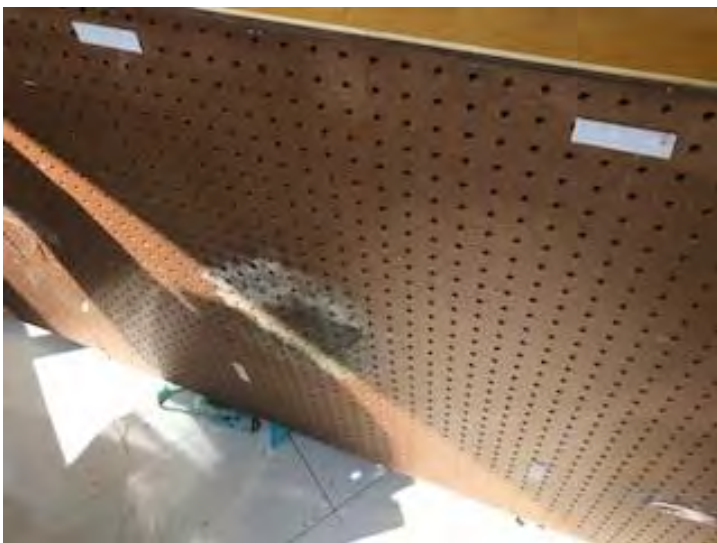
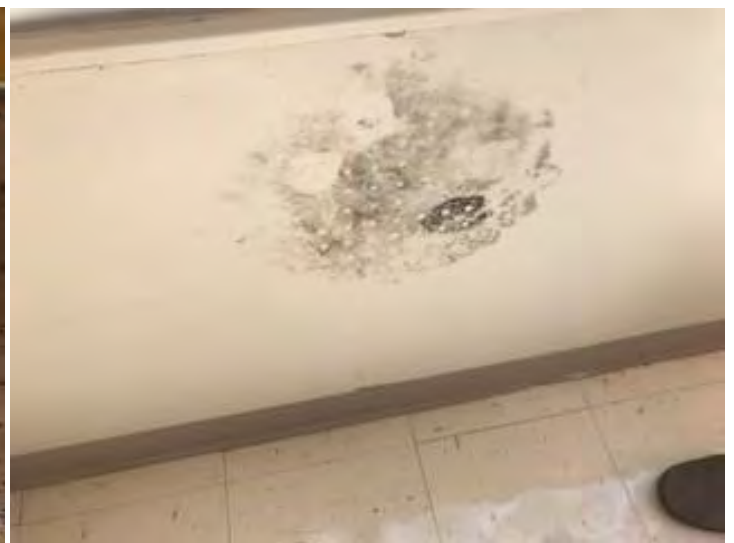
Figures 1.11-1.16 Above Show Microbial Growth Hidden Behind Rugs, Mats, and Boards

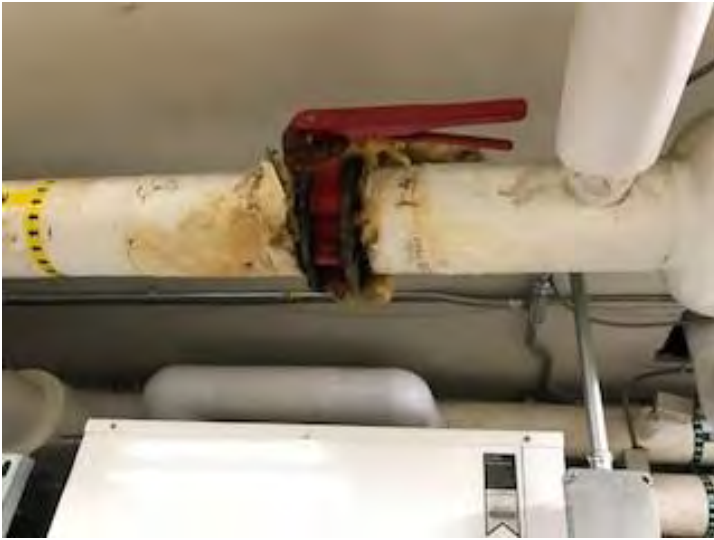
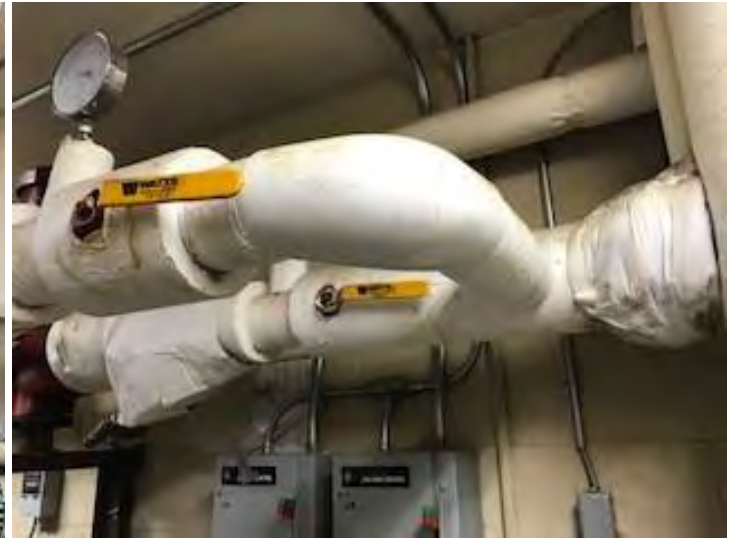
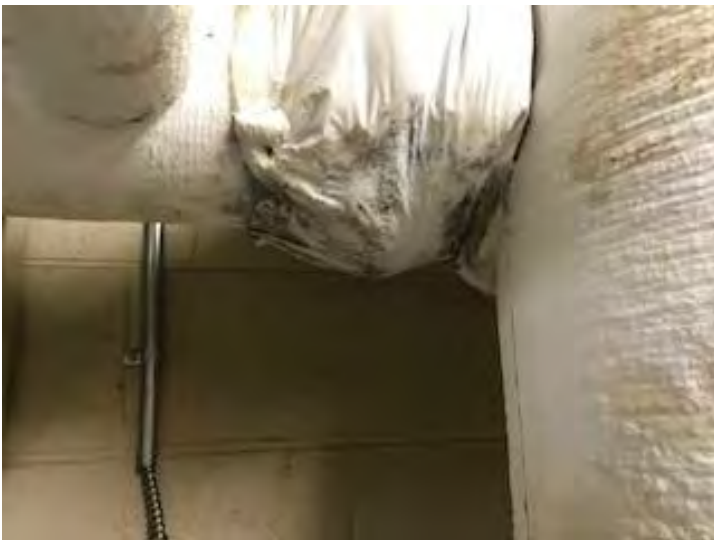
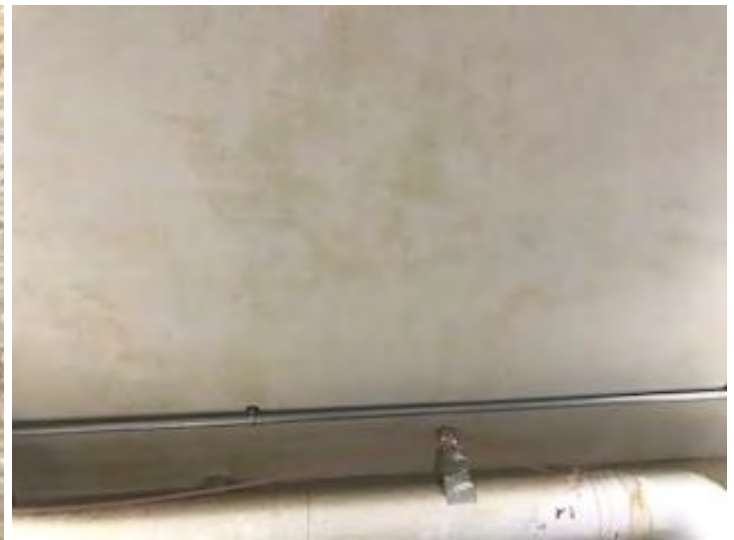
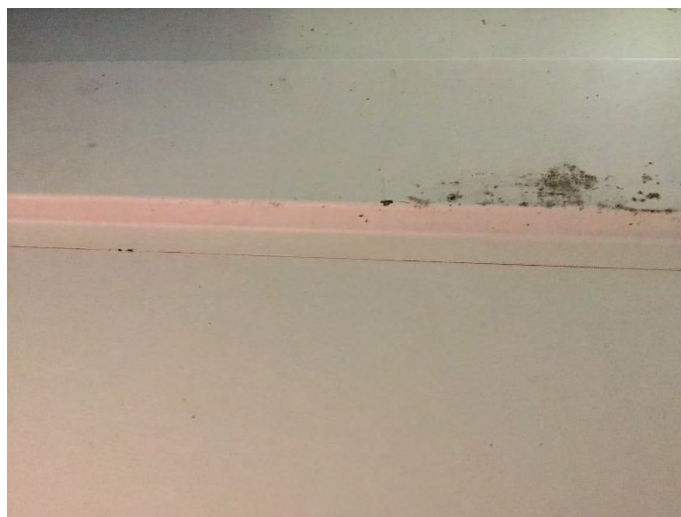
1. Preliminary inspection of the building identified visual suspected fungal growth occurring on various surfaces and materials within the building. The growth appeared to be surficial in nature and likely the result of high humidity. See photos: Appendix A
2. Further inspection of the building identified visual suspected fungal growth behind cabinets, various room contents, HVAC vents, on and behind cove base moldings along sheetrock walls. Fungal growth was also observed above ceilings on various pipe insulations.

Figures 1.17-1.21 Above Show Microbial Growth On and Around Pipes and Pipe Insulation

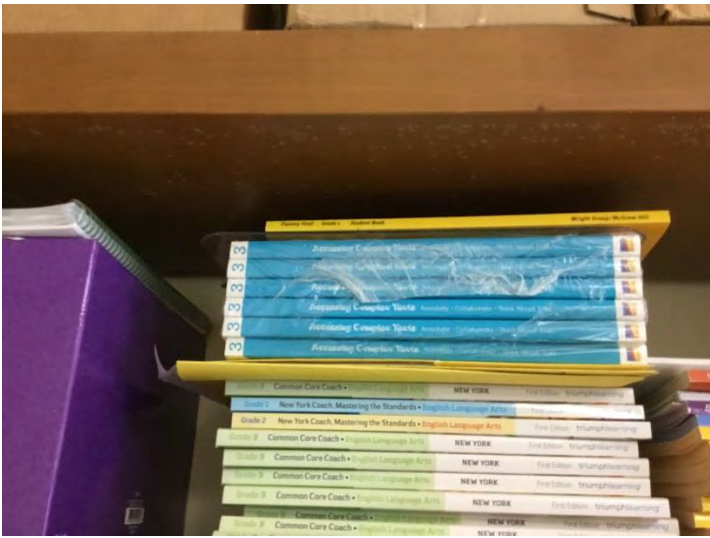
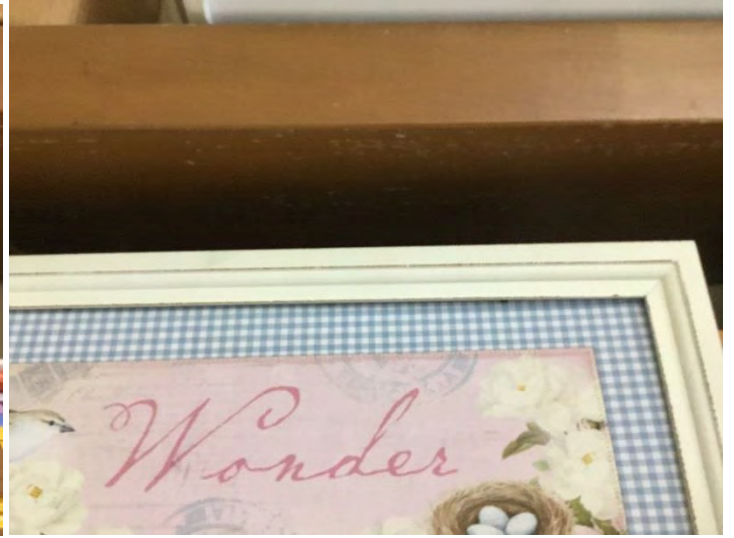
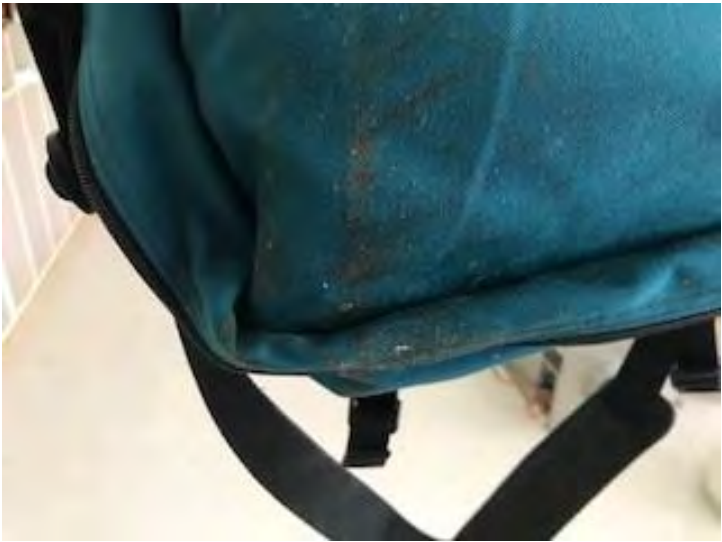
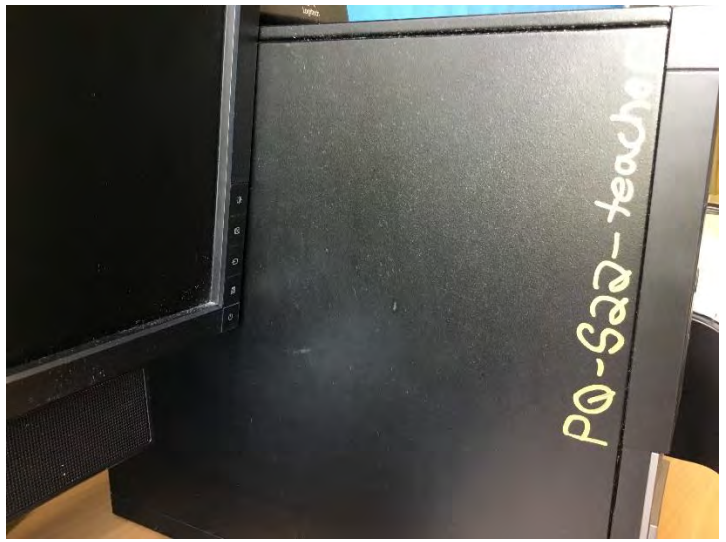
Figures 1.22-1.25 Above Show Microbial Growth on Various Materials (Wood, Plastic, Cloth)
